PLANNED WORKS SCOPING REPORT

**69 OLD ROAD, OLD HARLOW,
ESSEX CM17 0HF**

Report Ref: FP/LB69OR/251021

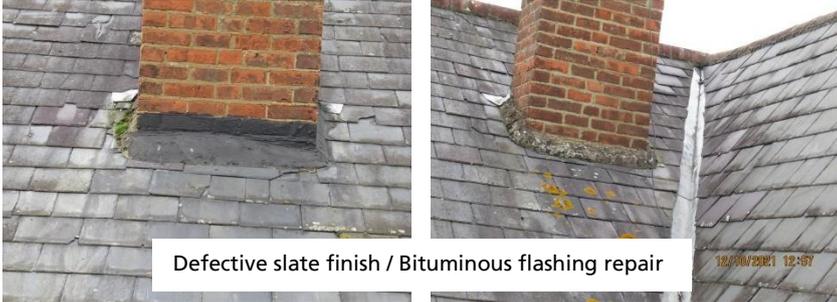
<p>Defective slate finish / Bituminous flashing repair</p>		
<p><u>External Walls, High-Level Joinery and Rainwater/Foul Waste Installation</u> The external blockwork and roughcast rendered walls are generally in satisfactory structural and serviceable condition. However, the following defects and issues are evident:-</p> <ol style="list-style-type: none"> 1. Render cracked to the front gable adjacent to the bedroom window and entrance hall (No apparent internal damp). 2. High internal damp readings at base of rear external walls within bedroom five, bathroom two, boiler room and adjacent kitchen side door (refer to floor plans – section 7) 3. Render plinth defective, blown and bridging damp proof course to perimeter compounded by high ground levels to the rear (refer to potential rising/bridging damp – item 2). 4. Evidence that floor vents have been concealed/blocked behind plinth (potential for condensation to floor voids). 5. Defective and leaking combined rainwater/foul water drainage installation coupled with cracked external render and sub-standard making good to the boiler flue resulting in penetrating damp (High damp readings and failure of internal plaster to lintel level of bedroom five). 6. External walls un-insulated with risk of condensation and damp coupled to high heat loss resulting in elevated energy costs. This is exacerbated within single storey kitchen addition where the wall depth is significantly reduced and base units restrict ventilation. There is evidence that damp and condensation is present where the internal wall surface is concealed. <p>Further investigation recommended prior to undertaking planned maintenance to fully ascertain cause of internal damp.</p> <p>Given the above issues with damp and poor thermal efficiency and requirements to meet HM) Amenity Standards, it is recommended that the walls are upgraded with rendered external wall insulation (EWI). Ground levels are lowered with addition floor vents and a replacement plinth installed. The render finish can be pigmented to remove the need for cyclical decoration.</p> <p>Where roof replacement and EWI are recommended, it will be necessary to replace all high-level joinery including the surface and foul water drainage installations to ensure the building envelope remains watertight and internal damp is mitigated. The existing timber joinery has been capped with plastic fascia, soffits and bargeboards.</p>

<p>Planned Works Cost – Replacement artificial slate finish including batten and type 1F felt - (103m2 @ £191.07)</p>	2022	£19,680
<p>Planned Works Cost - Full scaffolding allowance to facilitate main roof replacement above and high-level works - (183m2 wall area two storeys @ £25.94m2)</p>	2022	£4,747
<div data-bbox="284 1328 1121 1637" data-label="Image"> </div>		
<p><u>Chimney stacks</u> Brick built chimneys generally serviceable however repairs required to replace spalled/frost damaged brickwork, repoint brick joints and replace dated cement flunched flashing and bituminous repairs.</p> <p>Chimney flues are redundant and internally blocked/vented. However, stacks should be vented externally to prevent condensation within each flue.</p>		
<p>Planned Works Cost – Overhaul brick chimneys Replace defective brickwork, repoint and renew all flashings/back gutters, cap and ventilate flues.</p>	2022	£1,200

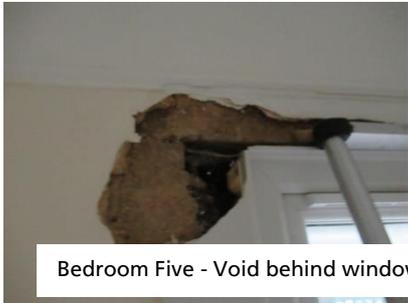
</div> <p style="text-align: center;">Bedroom Five - Void behind window trim. WC window boarded</p>		
<p><u>External Doors</u> Plastic framed double-glazed and panelled front entrance door has been removed to enable a security access door to be installed. The remaining plastic framed double glazed and solid panel side emergency egress doors are partially concealed by security panels.</p> <p>The doors could not be opened to check for defects and no FENSA certification was available.</p> <p>However they are likely to be the same age as the window installation and considered serviceable in terms of means of escape, security and thermal performance (refer to Fire Risk Assessment).</p> <p>It is recommended that the front door is replaced with the side doors overhauled to ensure a serviceable, secure and weathertight installation.</p>

External Element, Condition and Justification	Due Date	Budget Cost
<p>Planned Works Cost – Overhaul Window Installation Overhaul, ease/adjust and repair all windows on removal of security screens – 17no windows @ £45 each</p>	2022	£765
<div style="display: flex; justify-content: space-around;">

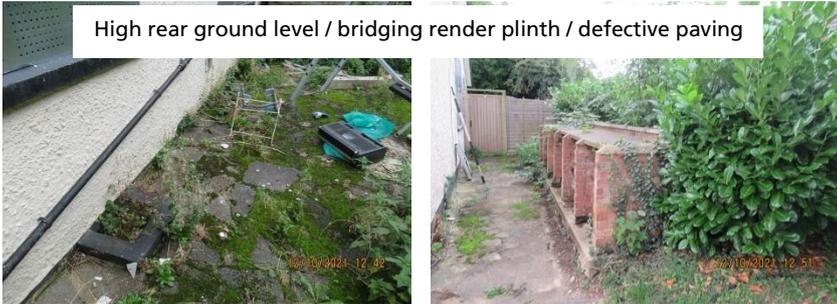
External Element, Condition and Justification	Due Date	Budget Cost
<p data-bbox="359 280 1045 324">High rear ground level / bridging render plinth / defective paving</p>

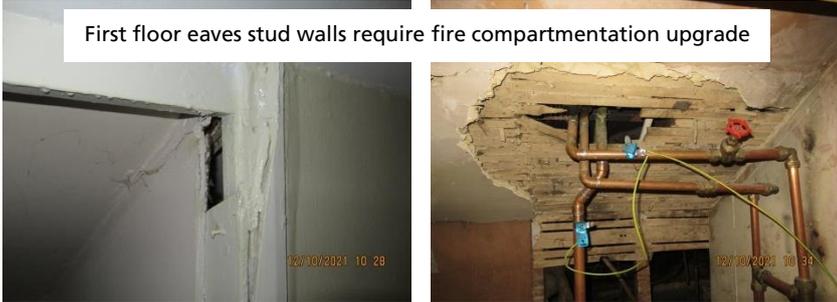
Internal Element, Condition and Justification	Due Date	Budget Cost
<p data-bbox="347 286 1050 331">First floor eaves stud walls require fire compartmentation upgrade</p>

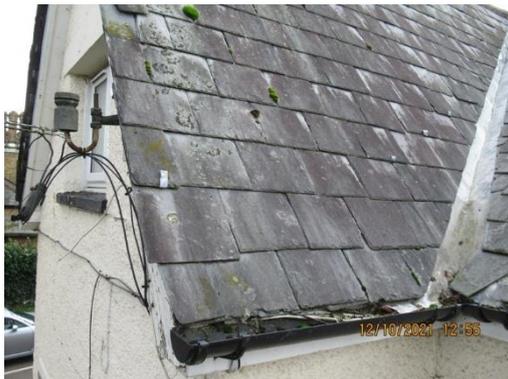
Roof finish – Defective slates and tingles evident

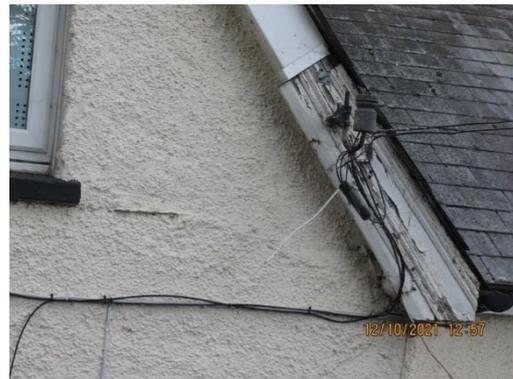
Front gable – Over capped timber fascia, failing decoration and blown render

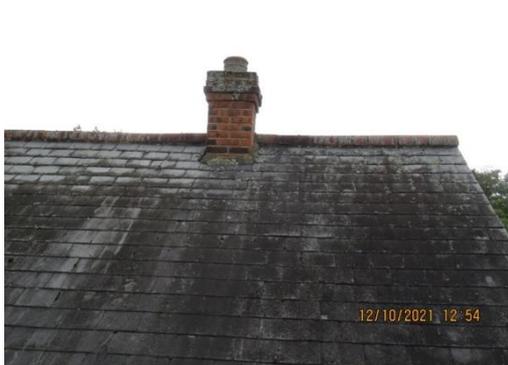
Cracked chimney flaunching and defective slates

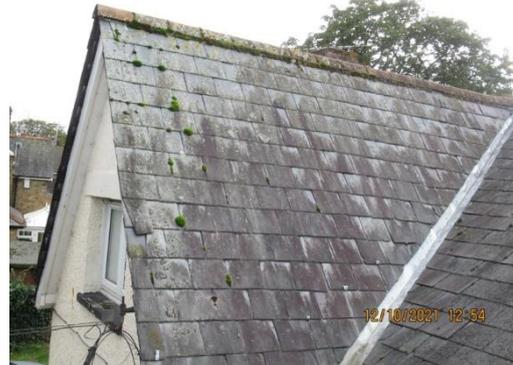
Roof finish – Defective slates and tingles evident

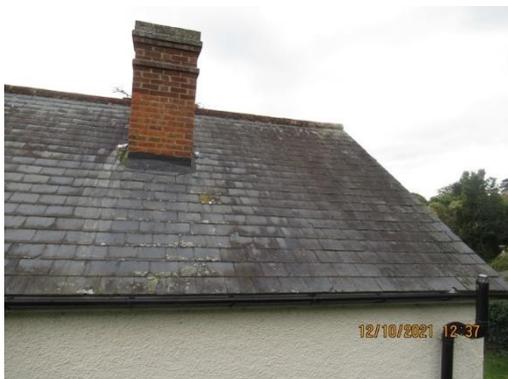
Roof finish – Defective slates evident

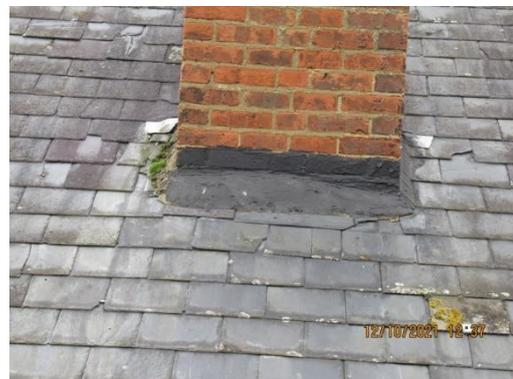
Roof finish – Defective slates and flashings evident

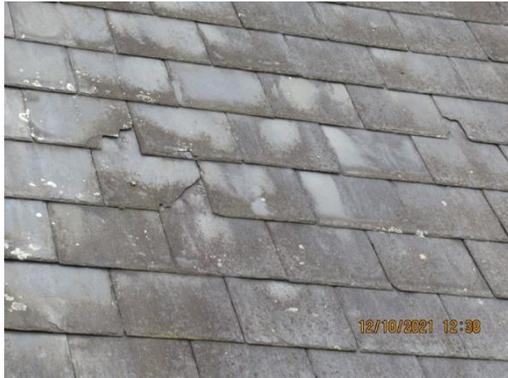
Roof finish – Defective slates evident

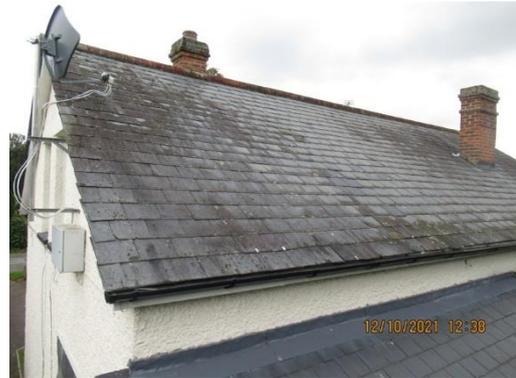
Roof finish – Defective slates and flashings evident

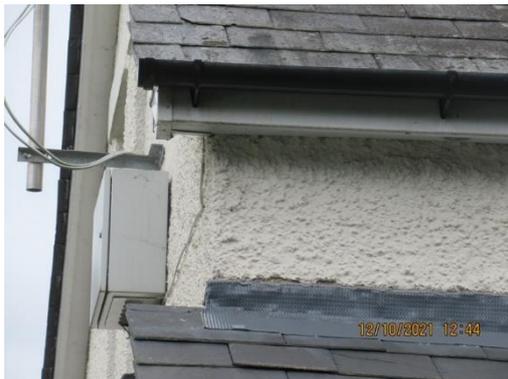
Defective flashing to kitchen addition

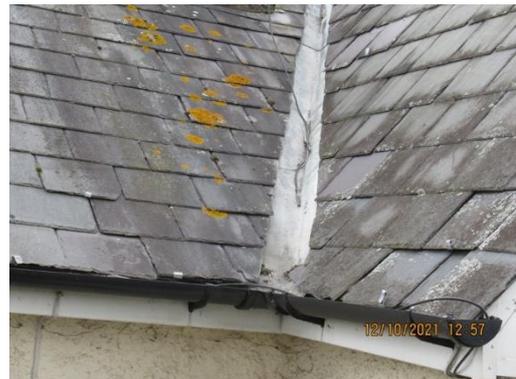
Roof finish – Defective slates evident

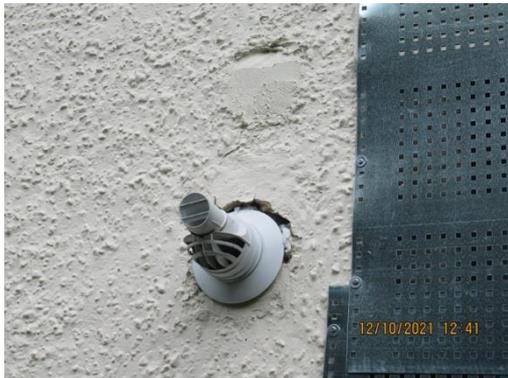
Defective render finish to boiler flue (Damp internally)

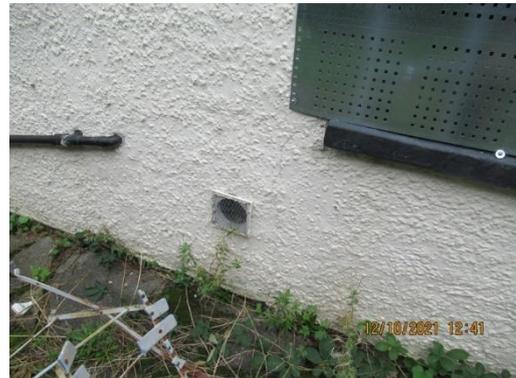
High rear ground levels and cracked render
(Damp to adjacent boiler room)

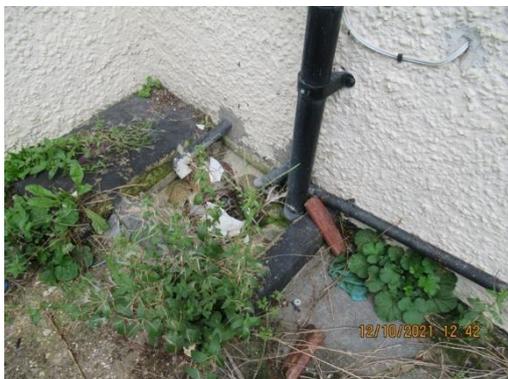
High rear ground level / Defective gutter and drainage
(Damp to adjacent WC /Bedroom Five)

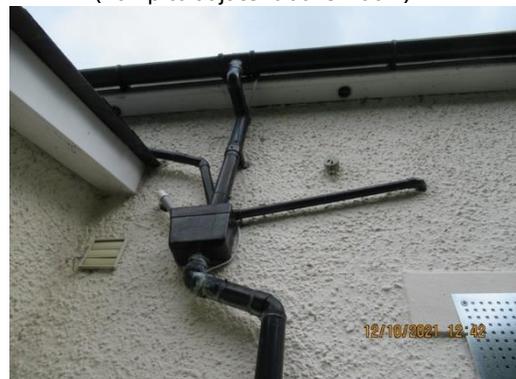
Combined foul and surface drainage into hopper

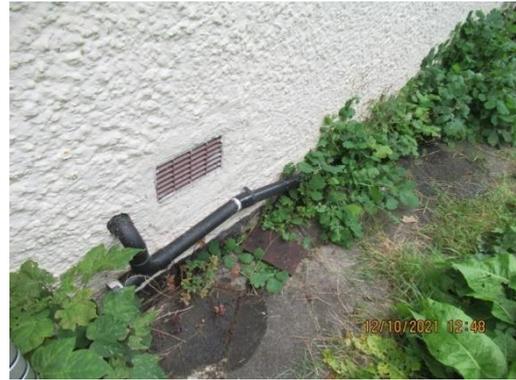
Defective foul waste pipes from kitchen

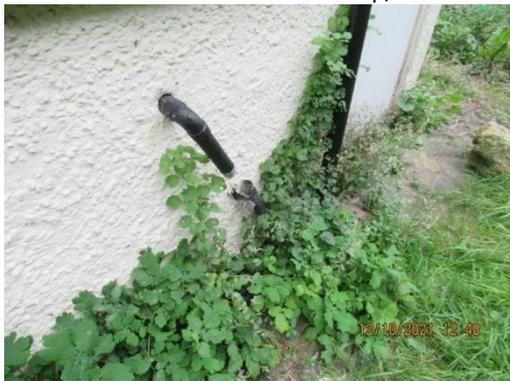
Defective foul waste pipes from kitchen

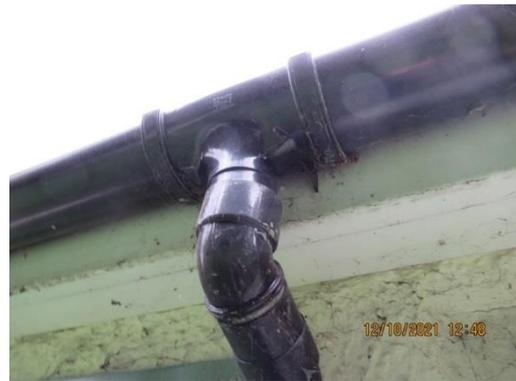
Leaking gutter outlet above kitchen addition

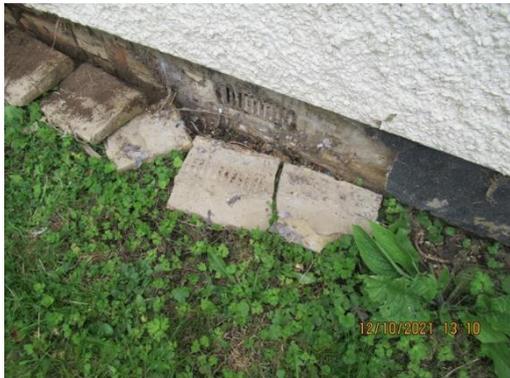
Sub-floor ventilation rendered over (Potential condensation risk)

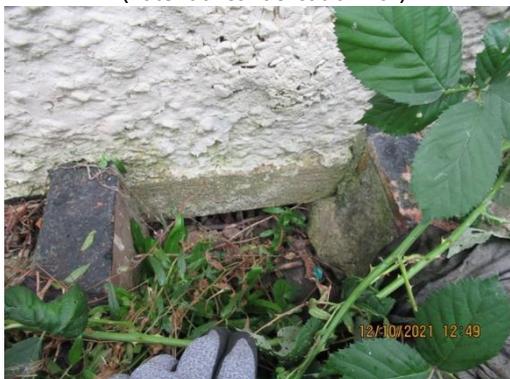
Inadequate sub-floor ventilation (Potential condensation risk)

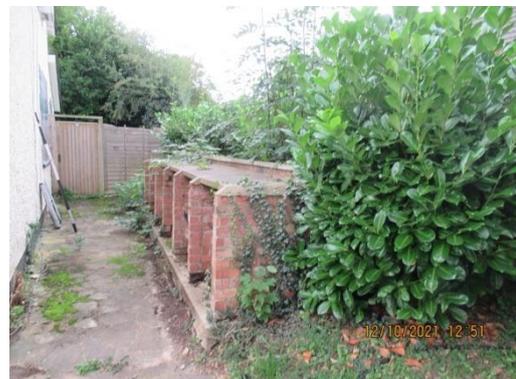
Dated side path and redundant refuse stores

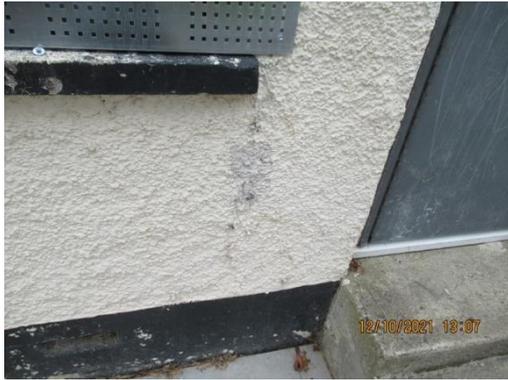
Front elevation – cracked render

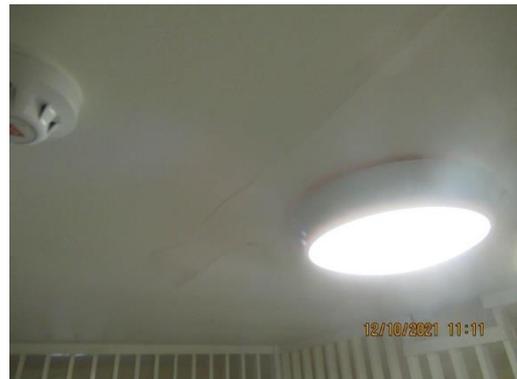
Cracks to stairwell ceiling

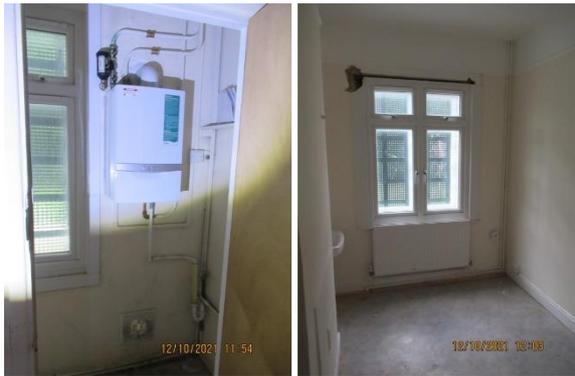
Boiler room and Bedroom Five
(Too small for sleeping accommodation)

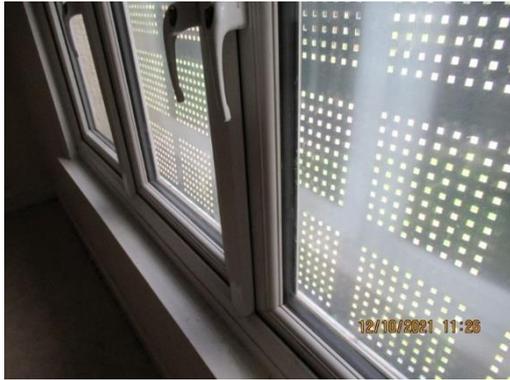
Windows in satisfactory condition
(Not tested due to security shutters)

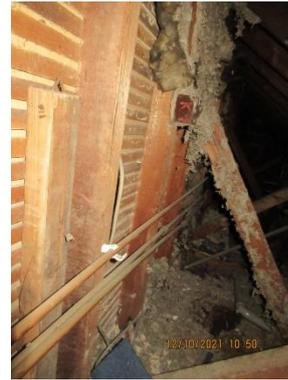
Eaves roof void - Remove debris, insulate and improve
fire compartmentation to stud walls.

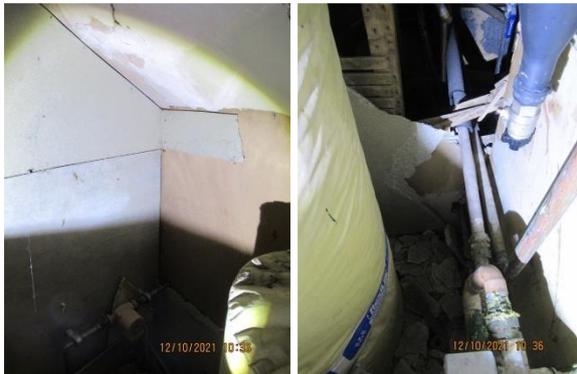
Fire compartmentation to eaves stud walls
requires improvement.

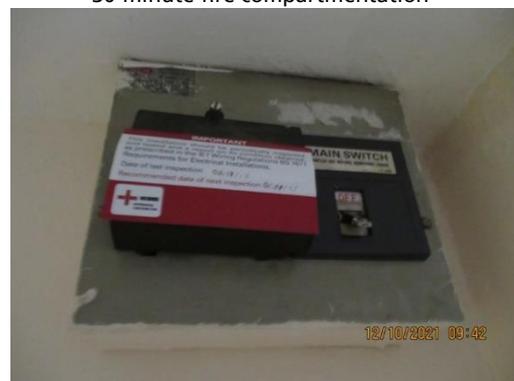
Dated consumer units to individual bedrooms
(Valid test date)

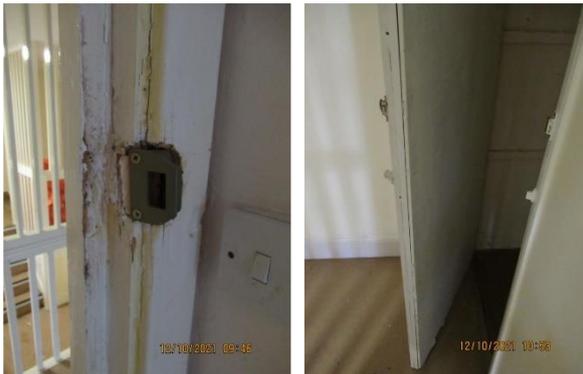
Bedroom/landing cup'd frames/doors compromise 30-minute fire compartmentation to escape routes

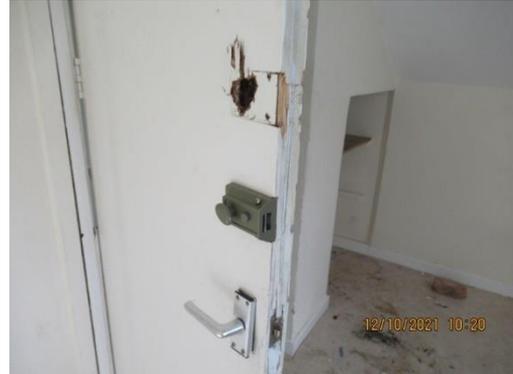
Bedroom Six – Defective fire door

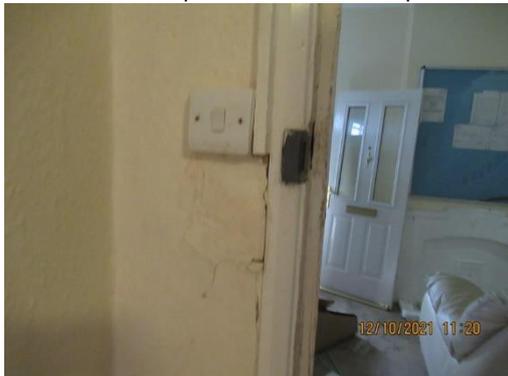
Bedroom Ten door frame compromise fire compartmentation / plaster blown

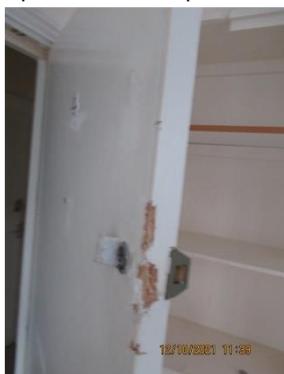
Bedroom Four – Defective fire door

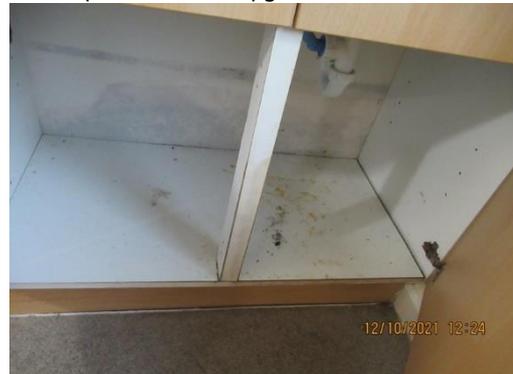
Kitchen units worn in some locations due to moisture ingress to carcass

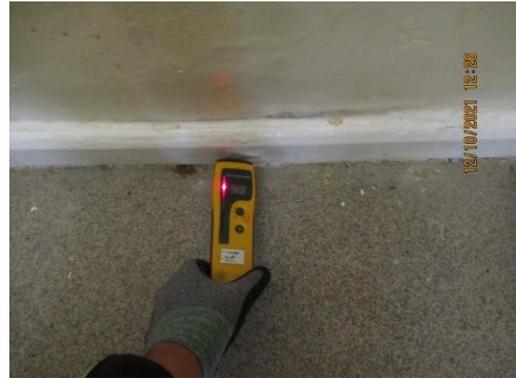
High moisture readings to base of rear kitchen wall

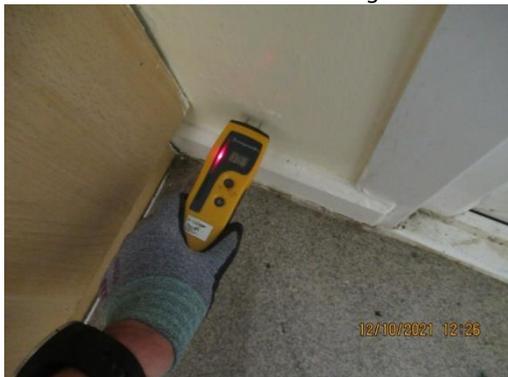
Kitchen rear wall only single skin of masonry with high moisture readings evident

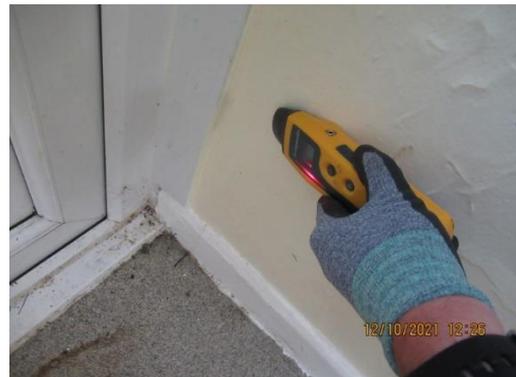
Kitchen rear wall - high moisture readings evident with blown plaster

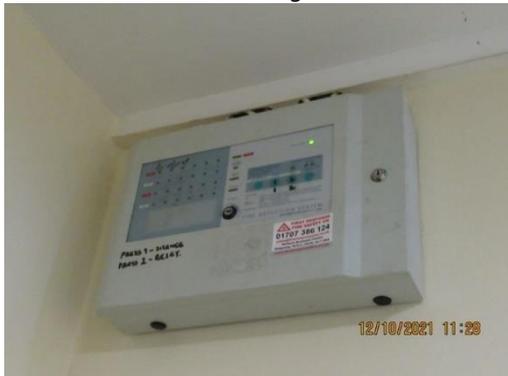
Fire detection control panel requires relocation to lower level (refer to Fire risk assessment)

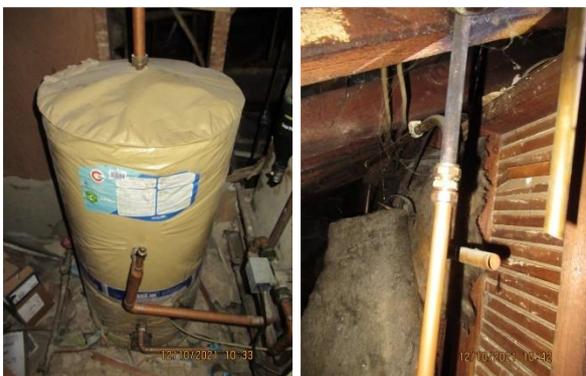
Hot water installation and plumbing require service and overhaul. Eaves stud wall un-insulated

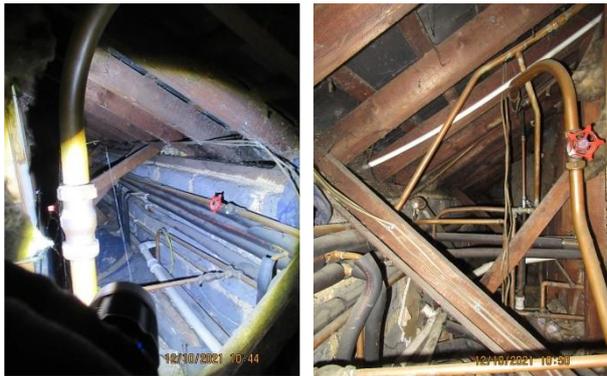
Excessive lengths of un-supported foul waste branch pipe with potential back falls. Un-insulated plumbing.

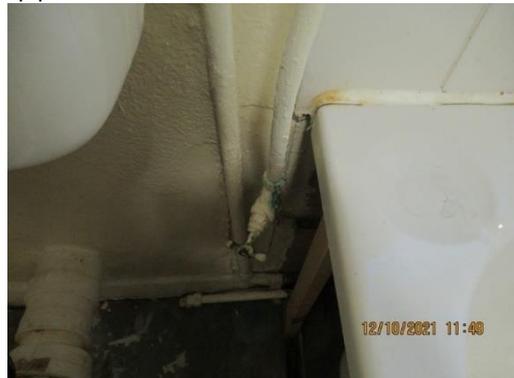
Dated plumbing with evidence of leaks (Bathroom One)

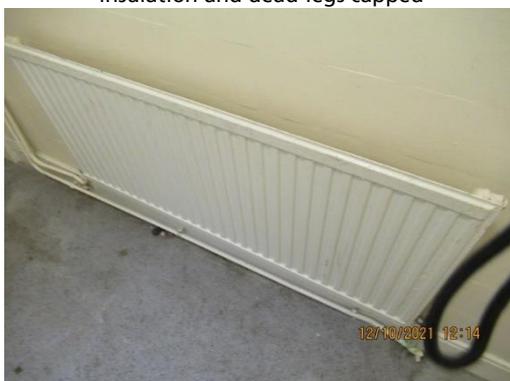
Heating installation requires test, service and overhaul

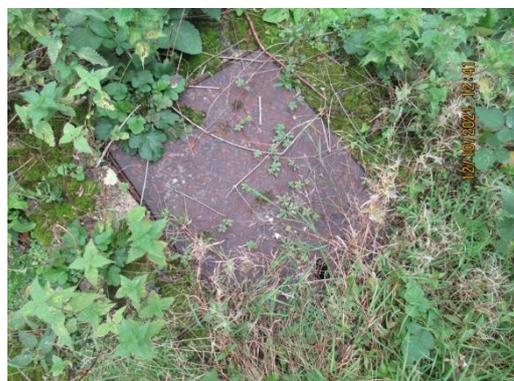
Defective rear inspection chamber cover

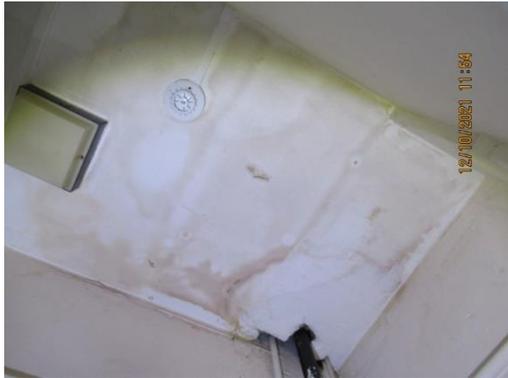
Evidence of leaks to plumbing waste within eaves void above boiler room

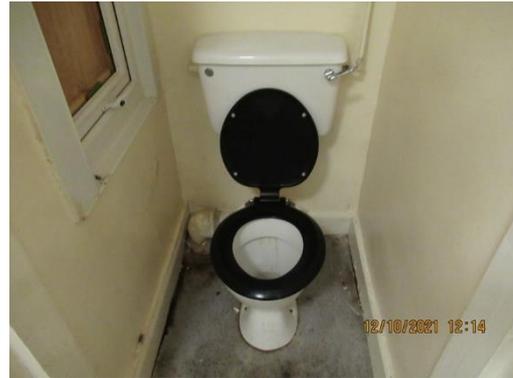
Bathroom two – High damp readings to base of all walls (Further investigation required)

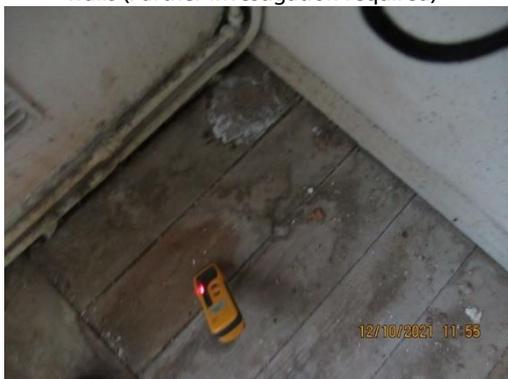
High moisture readings to floor boards within boiler room (Further investigation required)

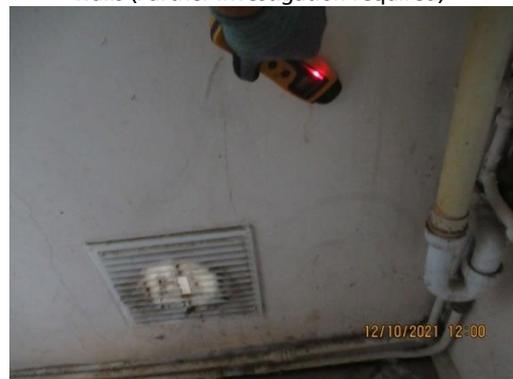
High moisture readings to base of rear wall within boiler room

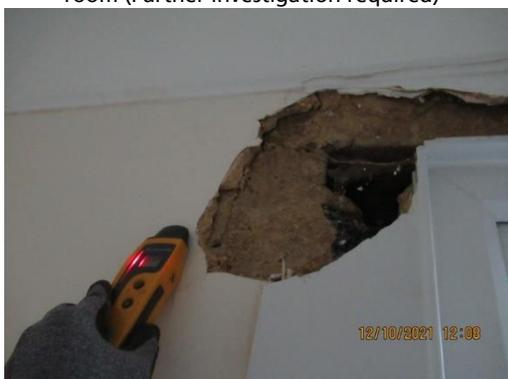
Defective plaster and void to window opening – tested damp (Bedroom Five)

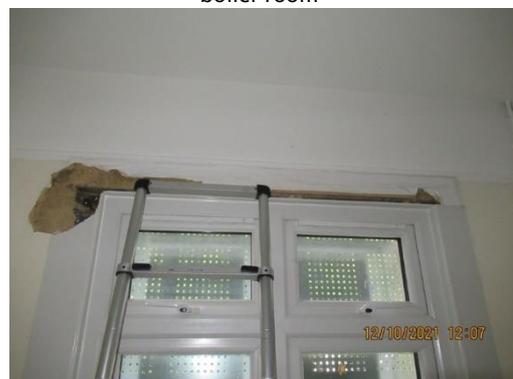
Defective plaster and void to window opening (Bedroom Five)

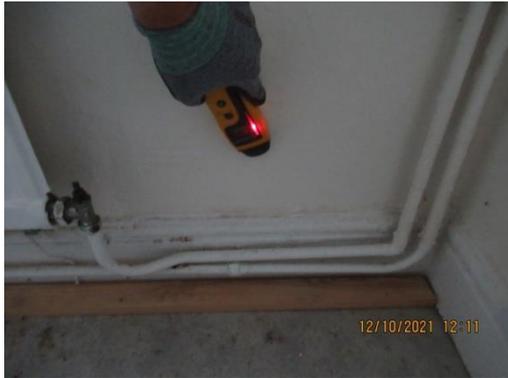
High moisture readings to base of rear wall within bedroom five

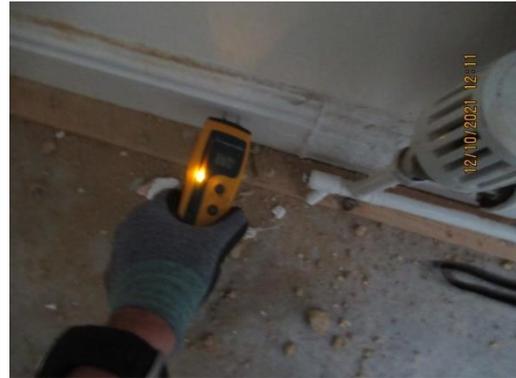
Elevated moisture readings to base of rear wall within bedroom five

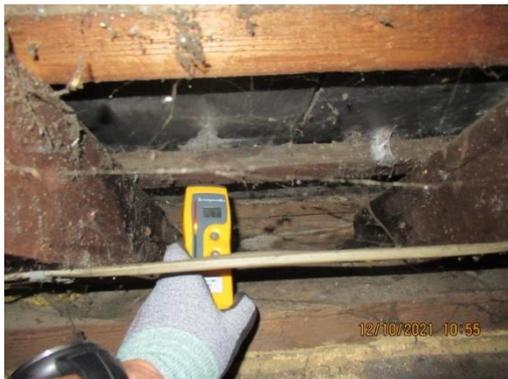
No sarking to roof with high moisture readings to battens

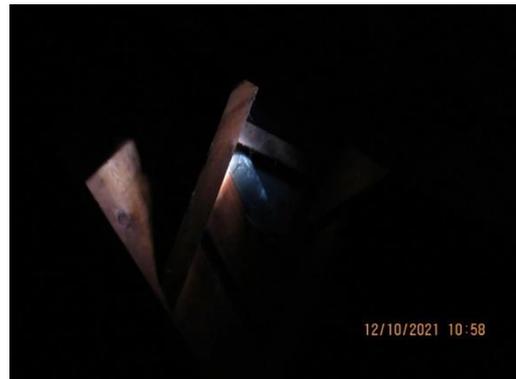
Daylight evident to roof space around valley gutter location

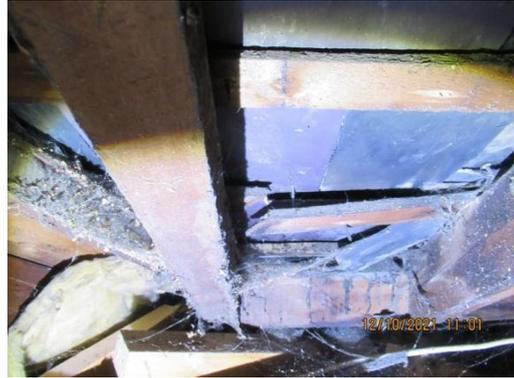
Roof battens split and damaged

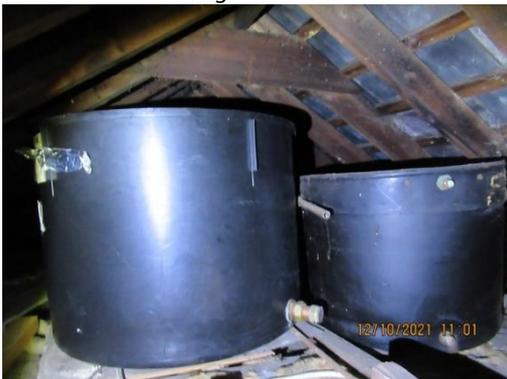
Redundant water tanks within roof space

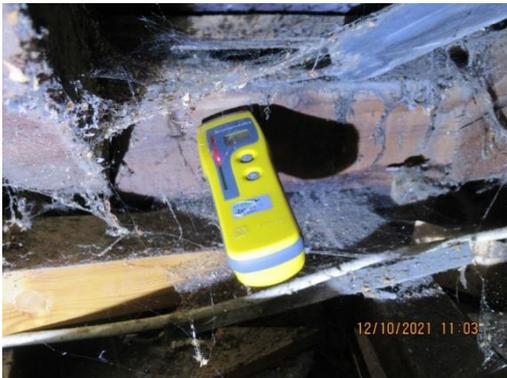
High moisture readings to roof structure

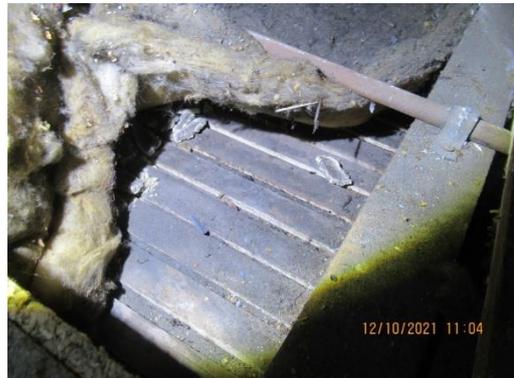
Original lath and plaster ceilings over boarded

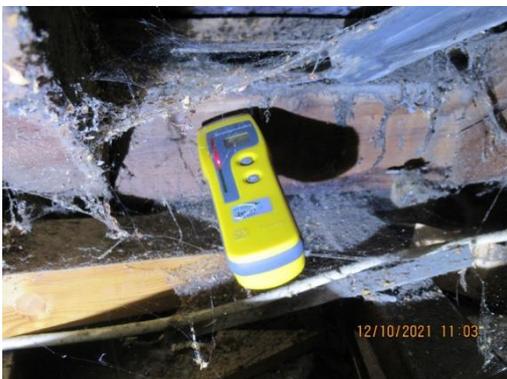
High moisture readings to roof structure

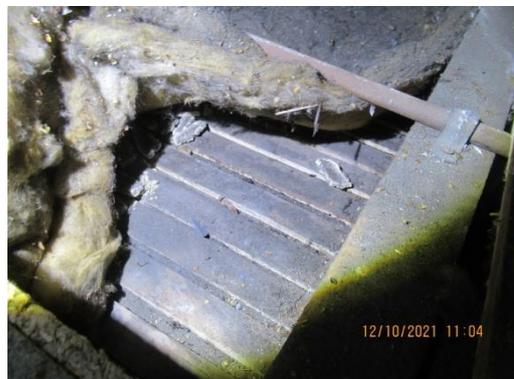
Original lath and plaster ceilings over boarded
