CONSIDERATION FOR DISPOSAL OF VOID PROPERTY

<i>Property Address and type</i>	<i>Reference Number</i>
3 East End Cottages Roydon CM19 5BS 2 Bedroom cottage Semi Detached property within conservation area not in Harlow.

Void Specification.

Address:	3 East End Cottages Roydon CM19 5BS.		
Tenant's Name(s):	Vacant Property		
Contact Tel:		Email:	-
Date of Inspection:	9/12/15	Date of Report:	15/12/15

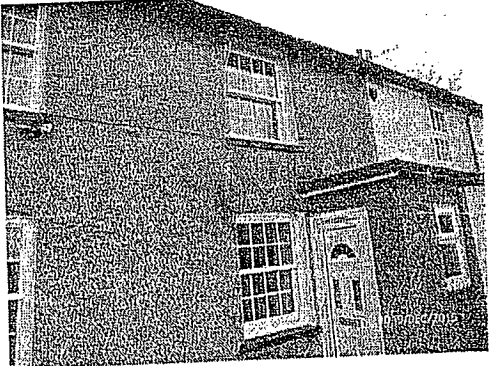
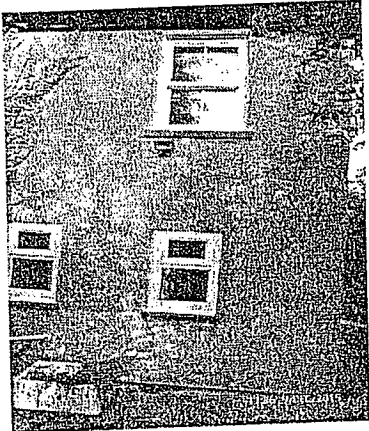
Location / Remarks	Image
<p><u>External Structure.</u></p> <p>The properties are surrounded by trees, high hedges.</p> <p>Planning confirmed that the property is not located within a conservation area and East End Cottages are not listed.</p> <p>Solid wall construction pebble dash finish in a poor state of repair. Evidence of numerous cracks and a number of areas received minor repairs.</p> <p>Short term, further repairs required, long term property would benefit from external insulation system, or full replacement of pebble dashing.</p> <p>The lower brickwork to the front of property has been rendered with a plinth that has also had a bitumen based sealant added over at the front.</p>

Slate roof covering has reached end of useful life and requires renewal including fascia, soffit, and gutter system and loft insulation. Due to age a number of rafters show signs of deflection, roof structure will require strengthening, possibly renewing a number of struts and rafters.

Chimney stack, pots and flaunching is in a poor condition and will require refurbishment.

Side entrance slate roof canopy to be removed and replaced with GRP canopy.

Front porch roof is currently water tight, but nearing the end of useful life and will require renewal.

Windows and entrance doors recently been replaced in double glazed PVCu.

Rear entrance floor level with external path, allowing water to penetrate causing dampness.

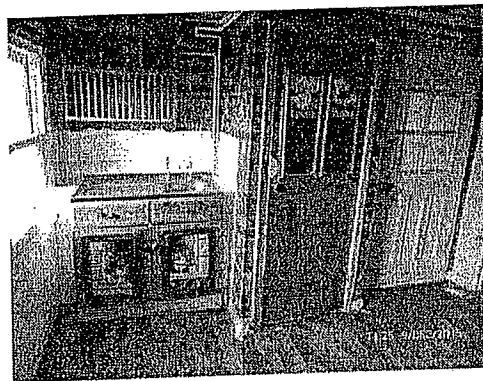
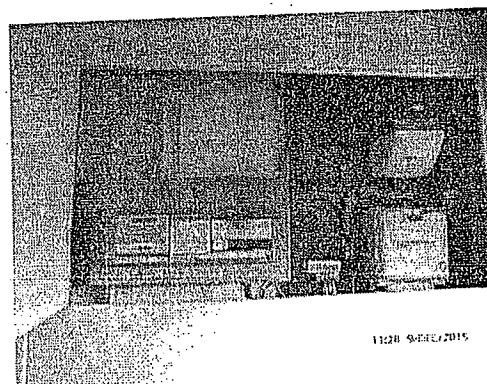
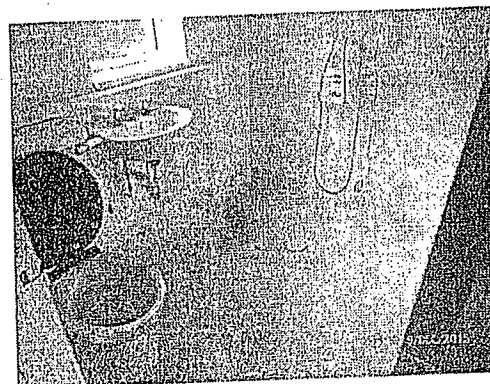
Apply full height thermal wall Insulation to walls and apply smooth cast plaster finish.

New Kitchen, redesign, possibly remove pantry and cylinder cupboard.

Remove old barrel pipework, re new plumbing supplies.

Partial re wire.

New wet room, flooring defective, needs renewing, forming continuous skirting to form water tight wet room floor.

Remove fire, Block up fire, vent, sweep flue, cap off chimneys.
