PLANNED WORKS SCOPING REPORT

**69 OLD ROAD, OLD HARLOW,
ESSEX CM17 0HF**

Report Ref: FP/LB69OR/251021

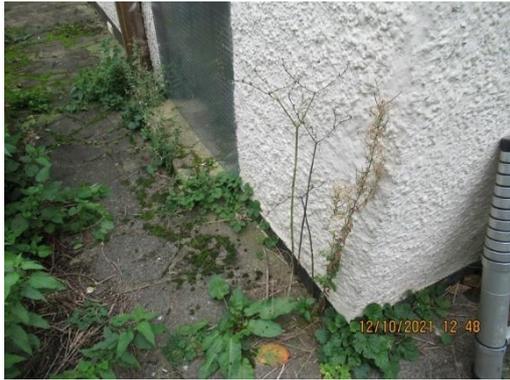
Rear path beyond serviceable lifespan (High ground levels with internal damp)

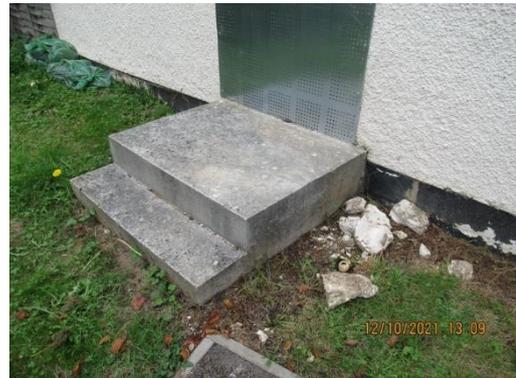
No emergency lighting to stepped emergency exit

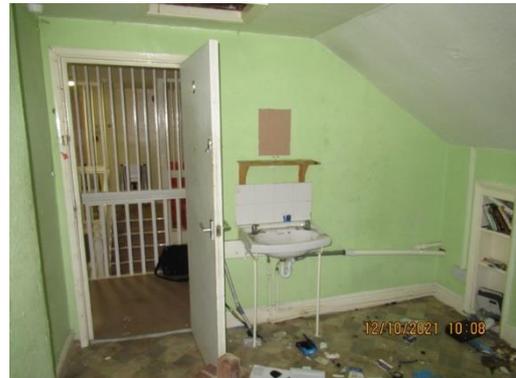
Bedroom Nine – Sloping ceiling / stud walls require insulation. Excessive waste pipe distance to soil pipe.

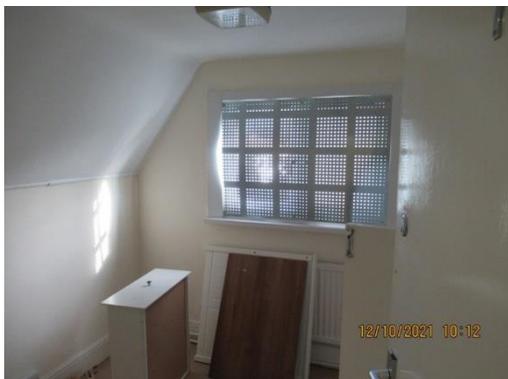
Bedroom Seven – Insufficient space for use as habitable room. Stud walls require fire compartmentation upgrade.

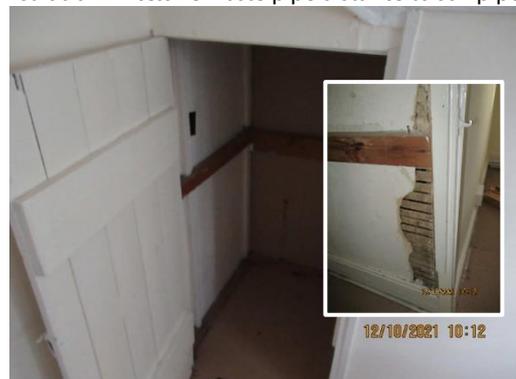
Bedroom Seven – Stud walls require fire compartmentation upgrade.

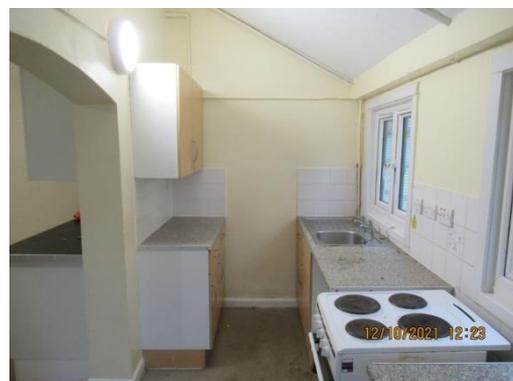
Kitchen addition – rear wall is single block skin and susceptible to damp and condensation

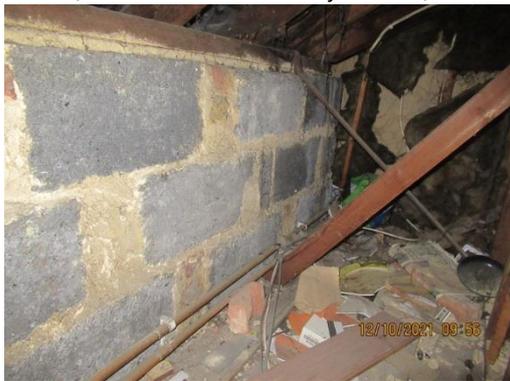
Eaves roof void
Remove combustible debris and insulate

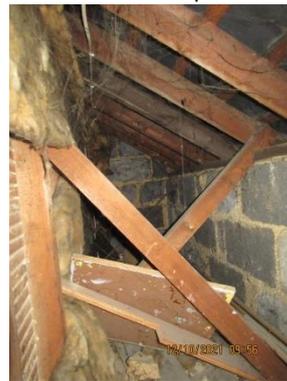
Eaves roof void - Remove debris, insulate and improve
fire compartmentation to stud walls.

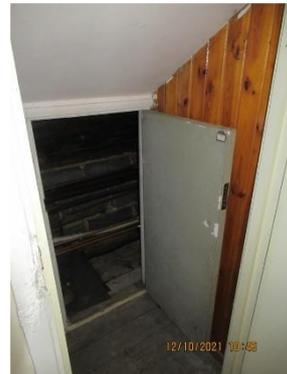
Access doors and partitions to roof eaves do not provide
30-minute fire compartmentation

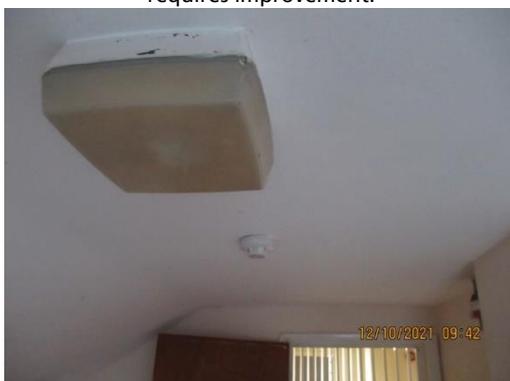
Dated light fittings to bedrooms

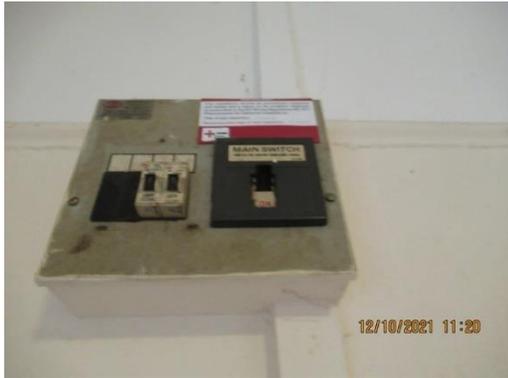
Dated consumer units to bedroom ten
(Valid test date)

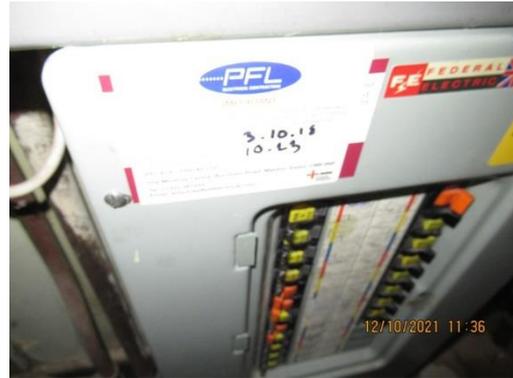
Main electrical intake and fuse board
(Dated - Valid test date)

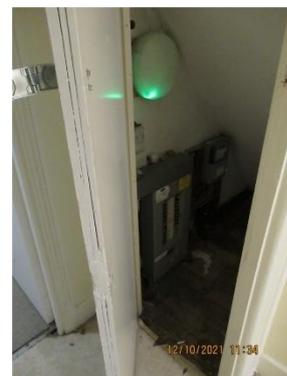
Under stair electrical intake cupboard requires fire compartmentation upgrade/fire door (FRA)

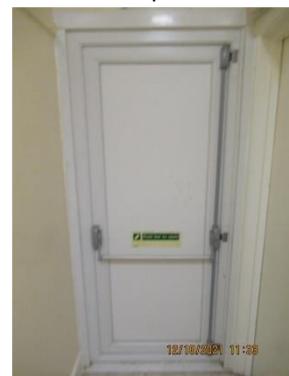
Side entrance fire escape – External lighting required (Refer to Fire risk assessment)

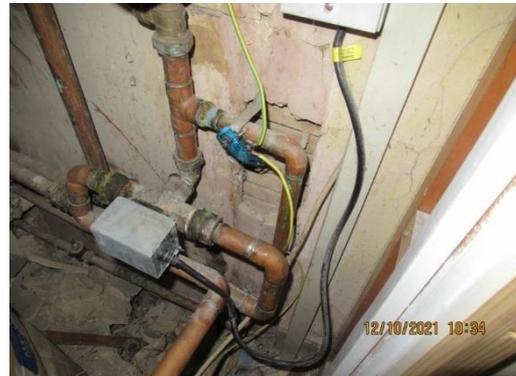
Heating/hot water installation requires service and

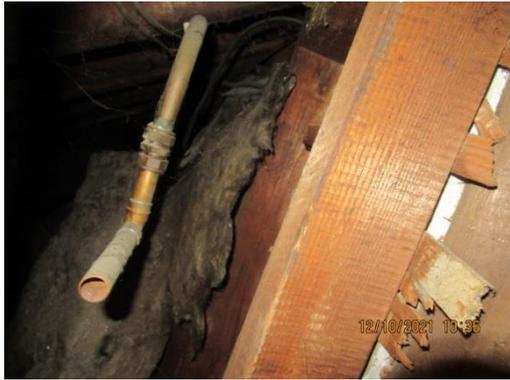
Redundant plumbing / Eaves stud walls require insulation & fire compartmentation upgrade

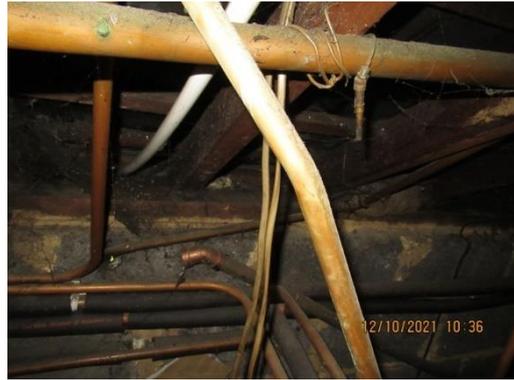
Plumbing services in eaves roof void require overhaul, insulation and dead-legs capped

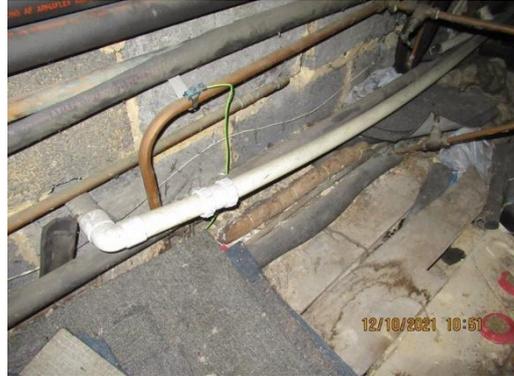
Excessive lengths of un-supported foul waste branch pipes with back fall. Combustible debris in void.

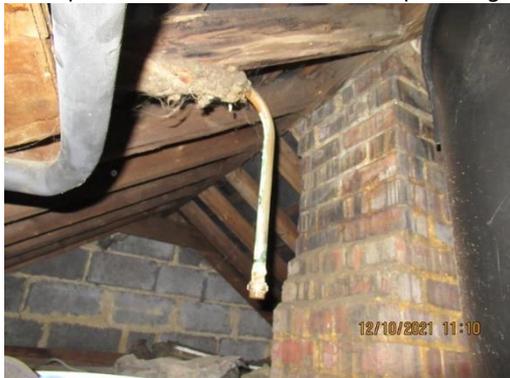
Plumbing services in eaves roof void require overhaul, insulation and dead-legs capped

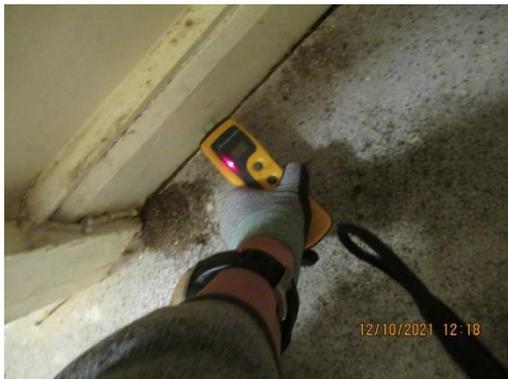
Bathroom two – High damp readings to base of all walls (Further investigation required)

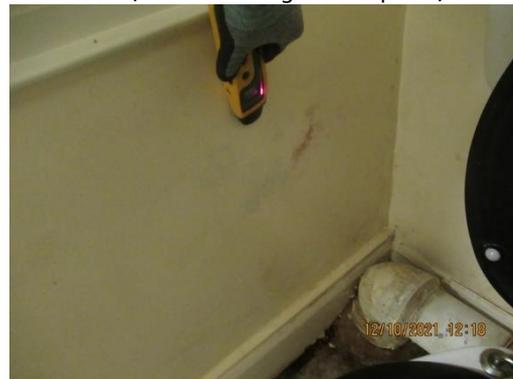
Bathroom two – High damp readings to base of all walls (Further investigation required)

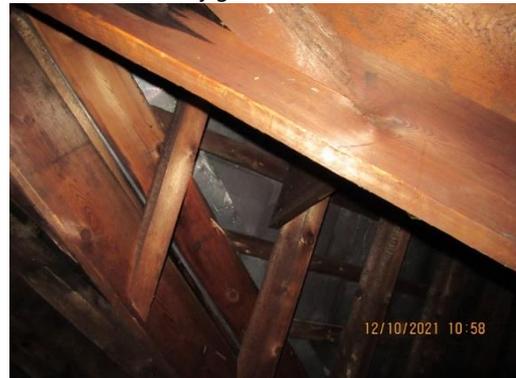
Daylight evident to roof space around valley gutter location

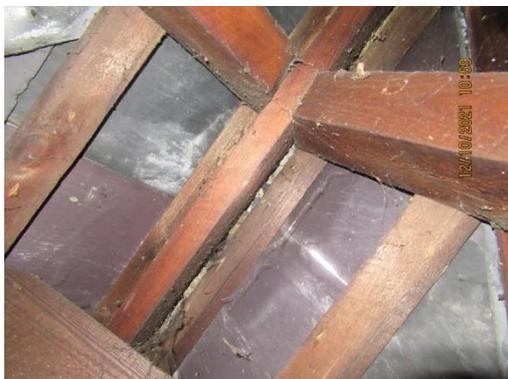
Gaps between roof slate finish

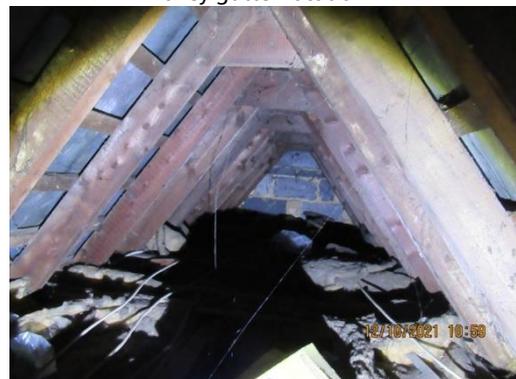
Roof insulation insufficient to modern standards

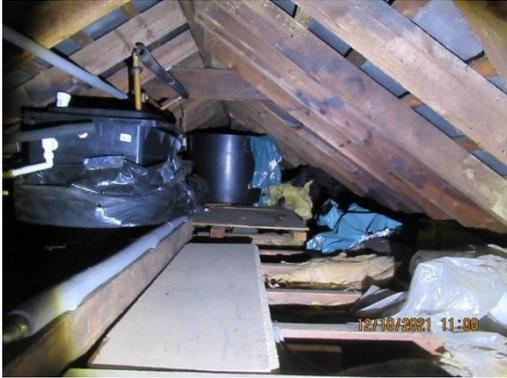
Roof insulation insufficient, redundant water tank, no sarking to roof finish

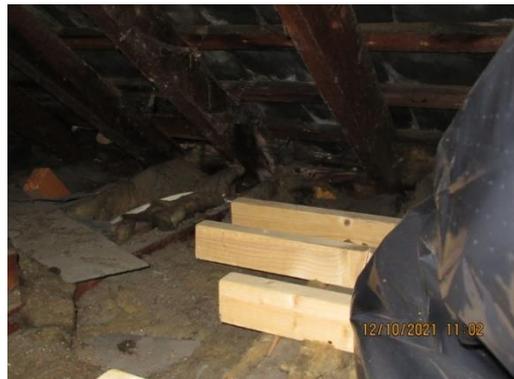
Minimal insulation and no sarking to roof finish
